## REBUILD OF THE M2A2 105MM HOWITZERS IN SOUTH VIETNAM (1971)

History Article by LTCOL David Miller RAEME (Retd)

**REBUILD OF 105MM M2A2 HOWITZERS  
BY 106 FD WKSP RAEME  
NUI DAT SOUTH VIETNAM 1971**

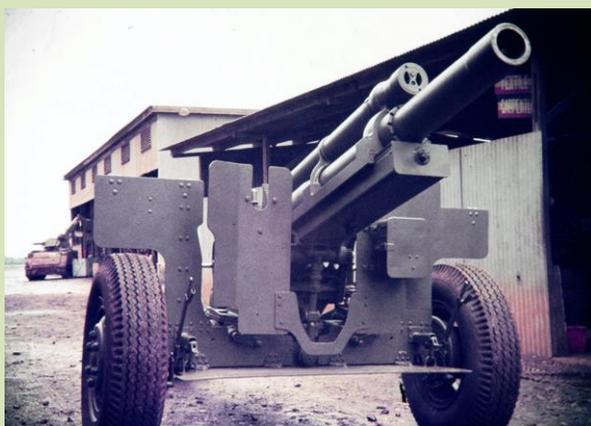
105 mm M2A2 Howitzer rebuilt by 106 Fd Wksp RAEME Nui Dat South Vietnam 1971.  
“A Veh” hangar in background. Photo by CAPT David Miller.

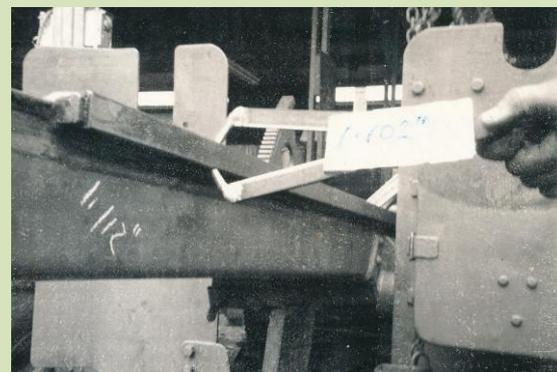
Cradle Brg Strip Gauge

The cradle bearing strips machining method and the hand finishing gave rise to some very tight cradle/sleigh fits as stresses released during transport of matched cradles & sleighs by truck from Vung Tau to Nui Dat.

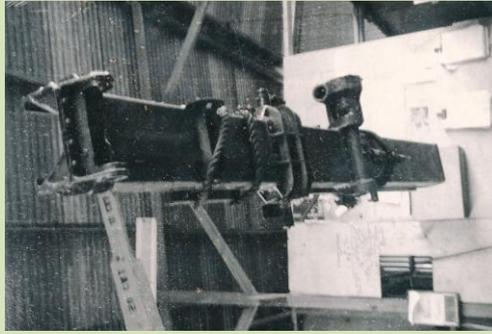
M2A2 Cradle for Transporting to 102 Fd Wksp Vung Tau

102 Fd Wksp at Vung Tau was contacted and asked to investigate machining options as we believed that the helicopter repair ship USS Corpus Christi had a heavy machining capability. This turned out not to be an option; however 102 Fd Wksp found that the US Air Base in Vung Tau had a large milling machine and the workshop could access it "after-hours". The US machine didn't have the required bed length so the workshop developed a "work-around" by machining the lengths in two serial operations and then hand finishing the strips with body files to suit the particular cradle.

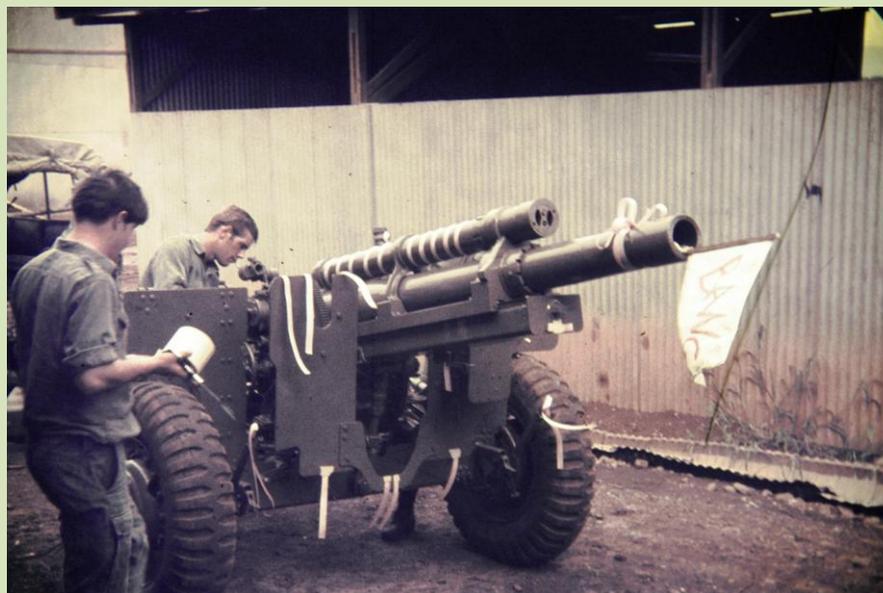
Last rebuilt M2A2 being prepared for delivery

The rebuilt guns were delivered with worn barrels, but all were within specified tolerances. Nearly every other sub-system was rebuilt to original specifications. The guns were repainted and, as per EMEIs, a brass plate was affixed to each gun detailing the rebuild by 106 Fd Wksp.
